Project No. 2628-065
R.L. Harris Hydroelectric Project
Transmittal of the Draft Erosion and Sedimentation Study Report

DRAFT
EROSION AND SEDIMENTATION
STUDY REPORT

R. L. HARRIS PROJECT
FERC NO. 2628

APRIL 2020

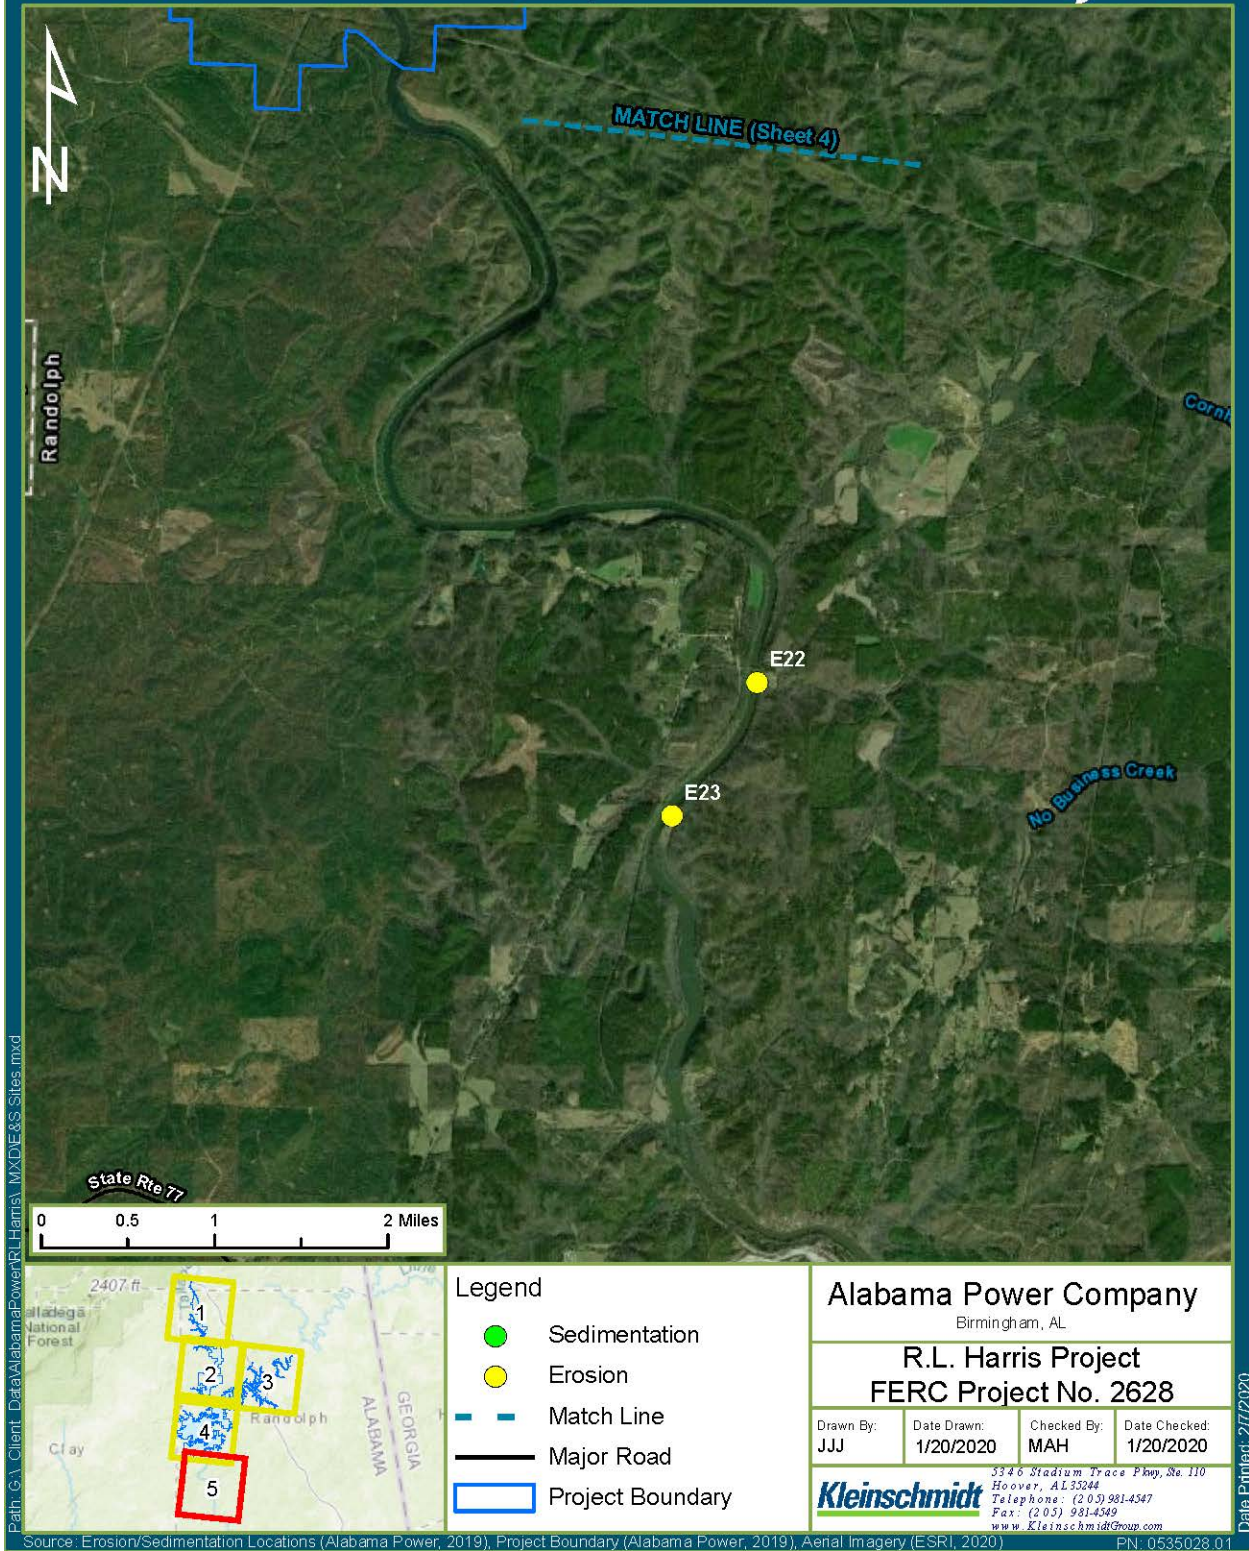
FIGURE 2-5 TALLAPOOSA RIVER EROSION SITES

The downstream survey results were also used to assess conditions for identified erosion sites 22 and 23 shown in Figure 2-5. These sites were assessed using the same criteria as the erosion sites located within Lake Harris (Appendix C). Both sites were confirmed to have areas of erosion primarily caused by adjacent land use/clearing and natural riverine processes.

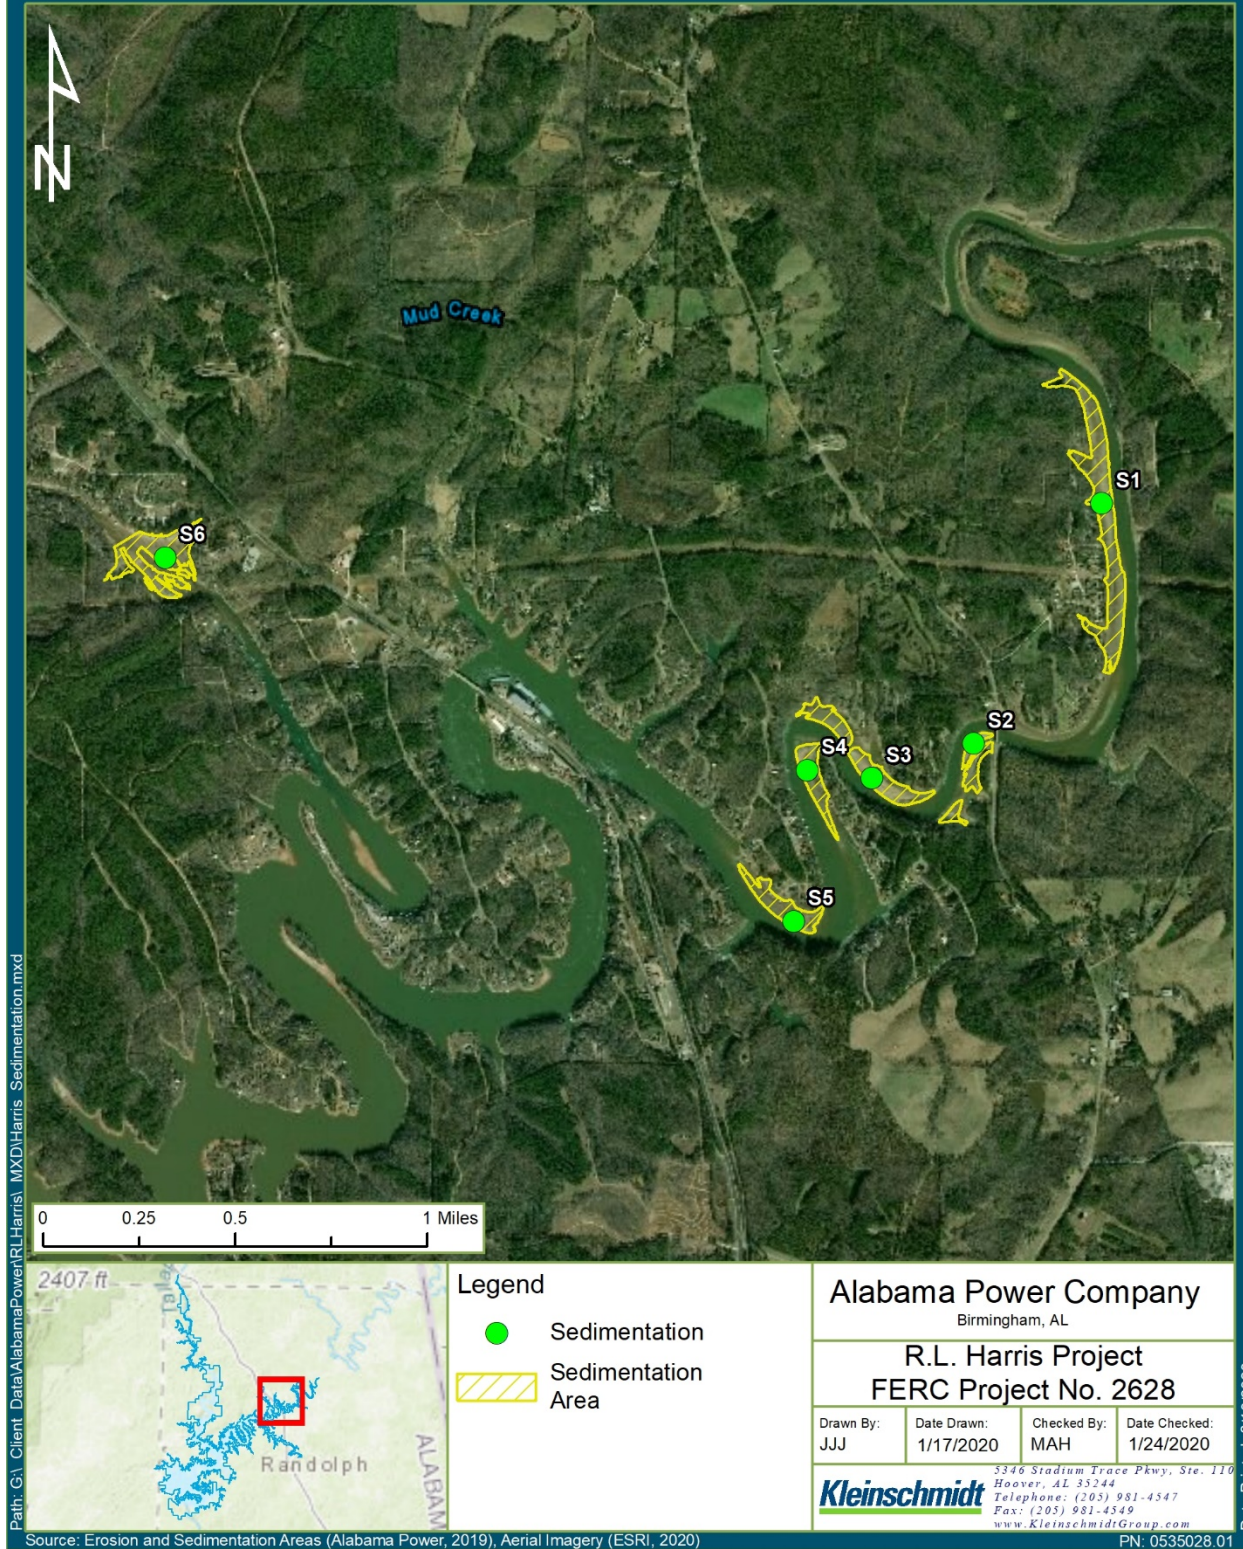
FIGURE 2-6 LITTLE TALLAPOOSA RIVER ARM SEDIMENTATION AREAS

Sedimentation areas on Lake Harris are primarily concentrated in the Little Tallapoosa arm where riverine flows enter the impoundment zone created by Lake Harris. To assess potential causes for sediment introduction to the system, land use classifications were analyzed for the Little Tallapoosa River basin in 2001 and compared to 2016 (Figure 2-10 and Figure 2-11). Table 2-3 shows the results of this analysis. Twenty-five percent of the Little Tallapoosa River basin has been converted to hay/pasture fields (MRLC 2019). Land clearing and conversion to agricultural fields is a significant contributing factor to sedimentation in the Little Tallapoosa arm of Lake Harris. A USGS model of total phosphorus, total nitrogen, suspended sediment, and streamflow for the southeastern U.S. supports this conclusion, showing high sediment yield for the Little Tallapoosa River basin (Hoos and Roland 2019).

Sedimentation in Lake Harris is most pronounced in the Little Tallapoosa River arm where sediment transported from upstream settles out of the water column as water velocities decrease. Land uses in the basin upstream of Lake Harris and adjacent to the river contribute sediment load to the upper reaches of Lake Harris. Alabama Power will perform additional reconnaissance at identified sedimentation sites on Lake Harris during full (summer) pool conditions to determine

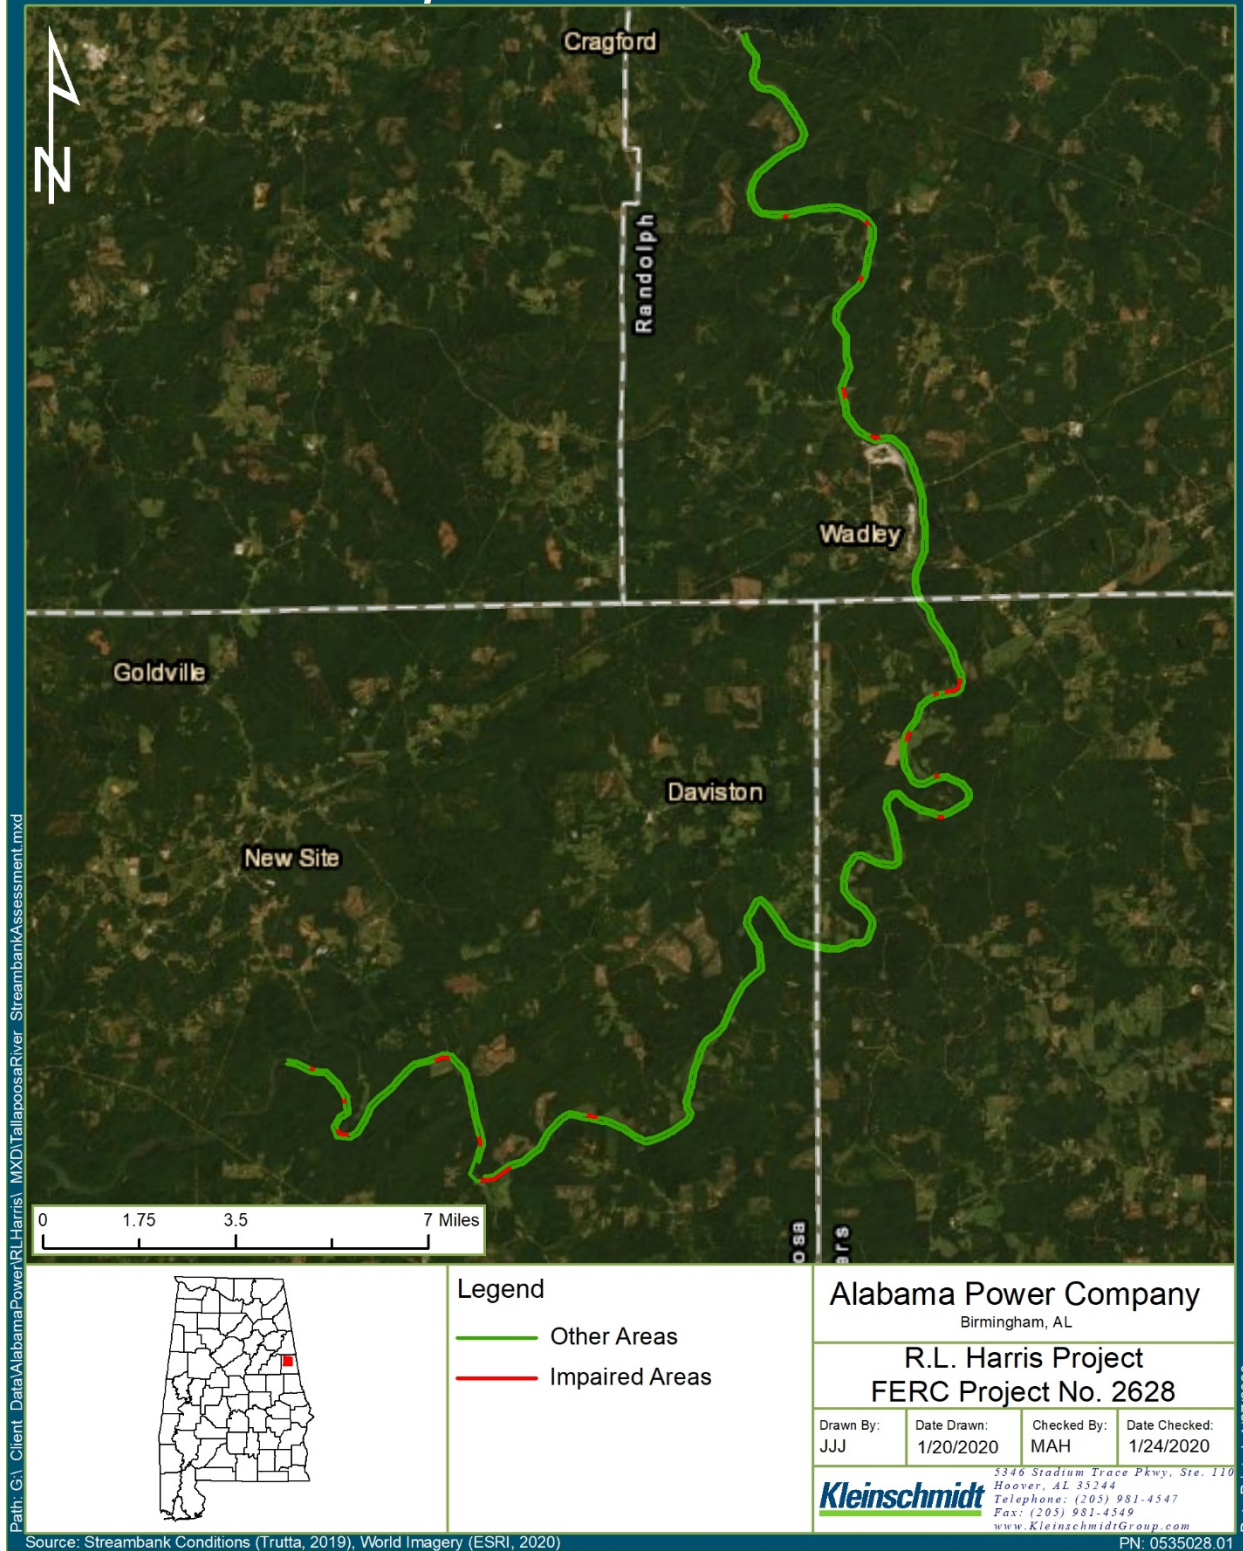
FIGURE 3-1 TALLAPOOSA IMPAIRED STREAMBANK CONDITION AREAS

Streambank condition point data collected during the Trutta survey was averaged into 0.1-mile (161 m) segments to help facilitate finding failing streambank areas. Using this data, Trutta developed a ranking system to understand specific areas of failing streambanks on the Tallapoosa River (Table 3-2 and Figure 3-1). A total of 20 sites, rather than 15 sites, were provided for the left bank segments as many segments were tied with a score of 3 (slightly impaired). Notably, only one area scored as impaired to non-functional. This area was located on the right bank between river mile 16.3 to 16.9 (Figure 3-2). Trutta’s report is provided in Appendix E.

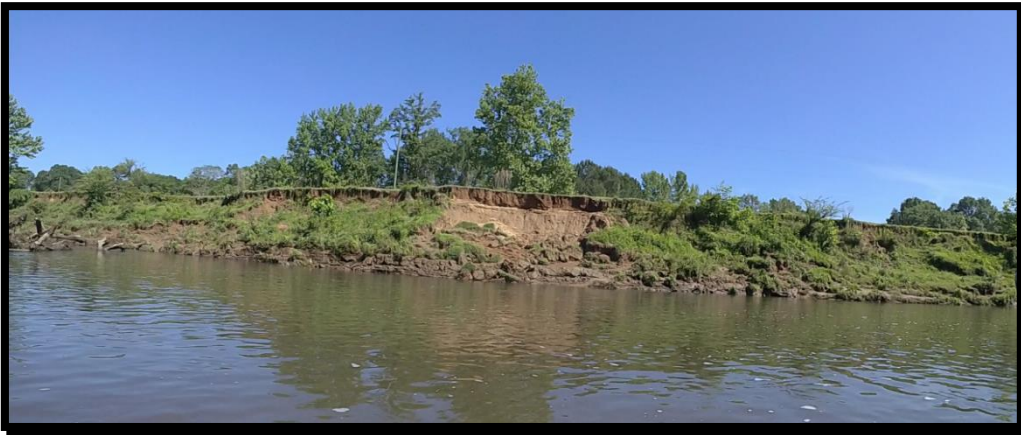
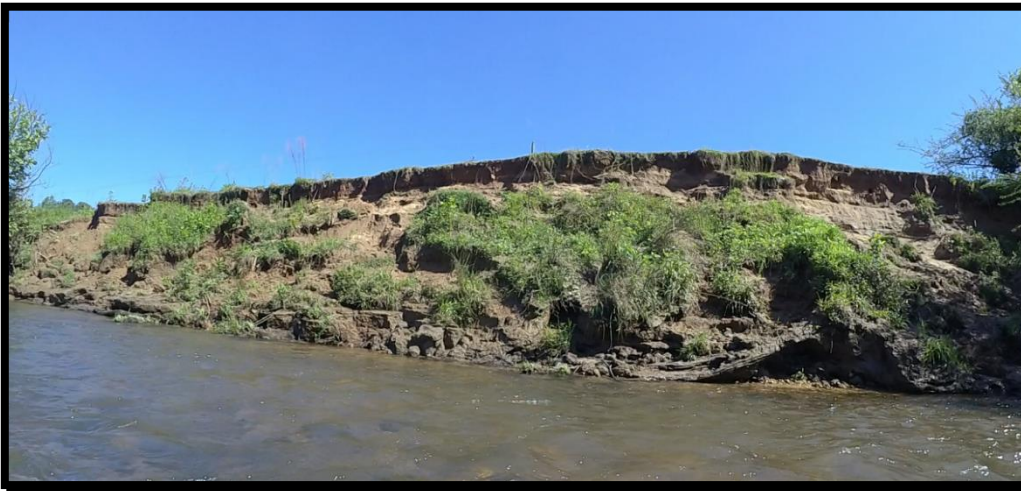
Interestingly, only one area scored as impaired to non-functional. This area was located on the right bank between river mile 16.3 to 16.9 (Figure 24). This is a very positive finding as many rivers we have surveyed in the Southeastern US have much more extensive bank erosion issues.

Figure 24: Example images of worst area on right bank of the Tallapoosa River between river mile 16.3 and 16.9.
