EROSION AND SEDIMENTATION STUDY REPORT

R.L. HARRIS HYDROELECTRIC PROJECT

FERC No. 2628

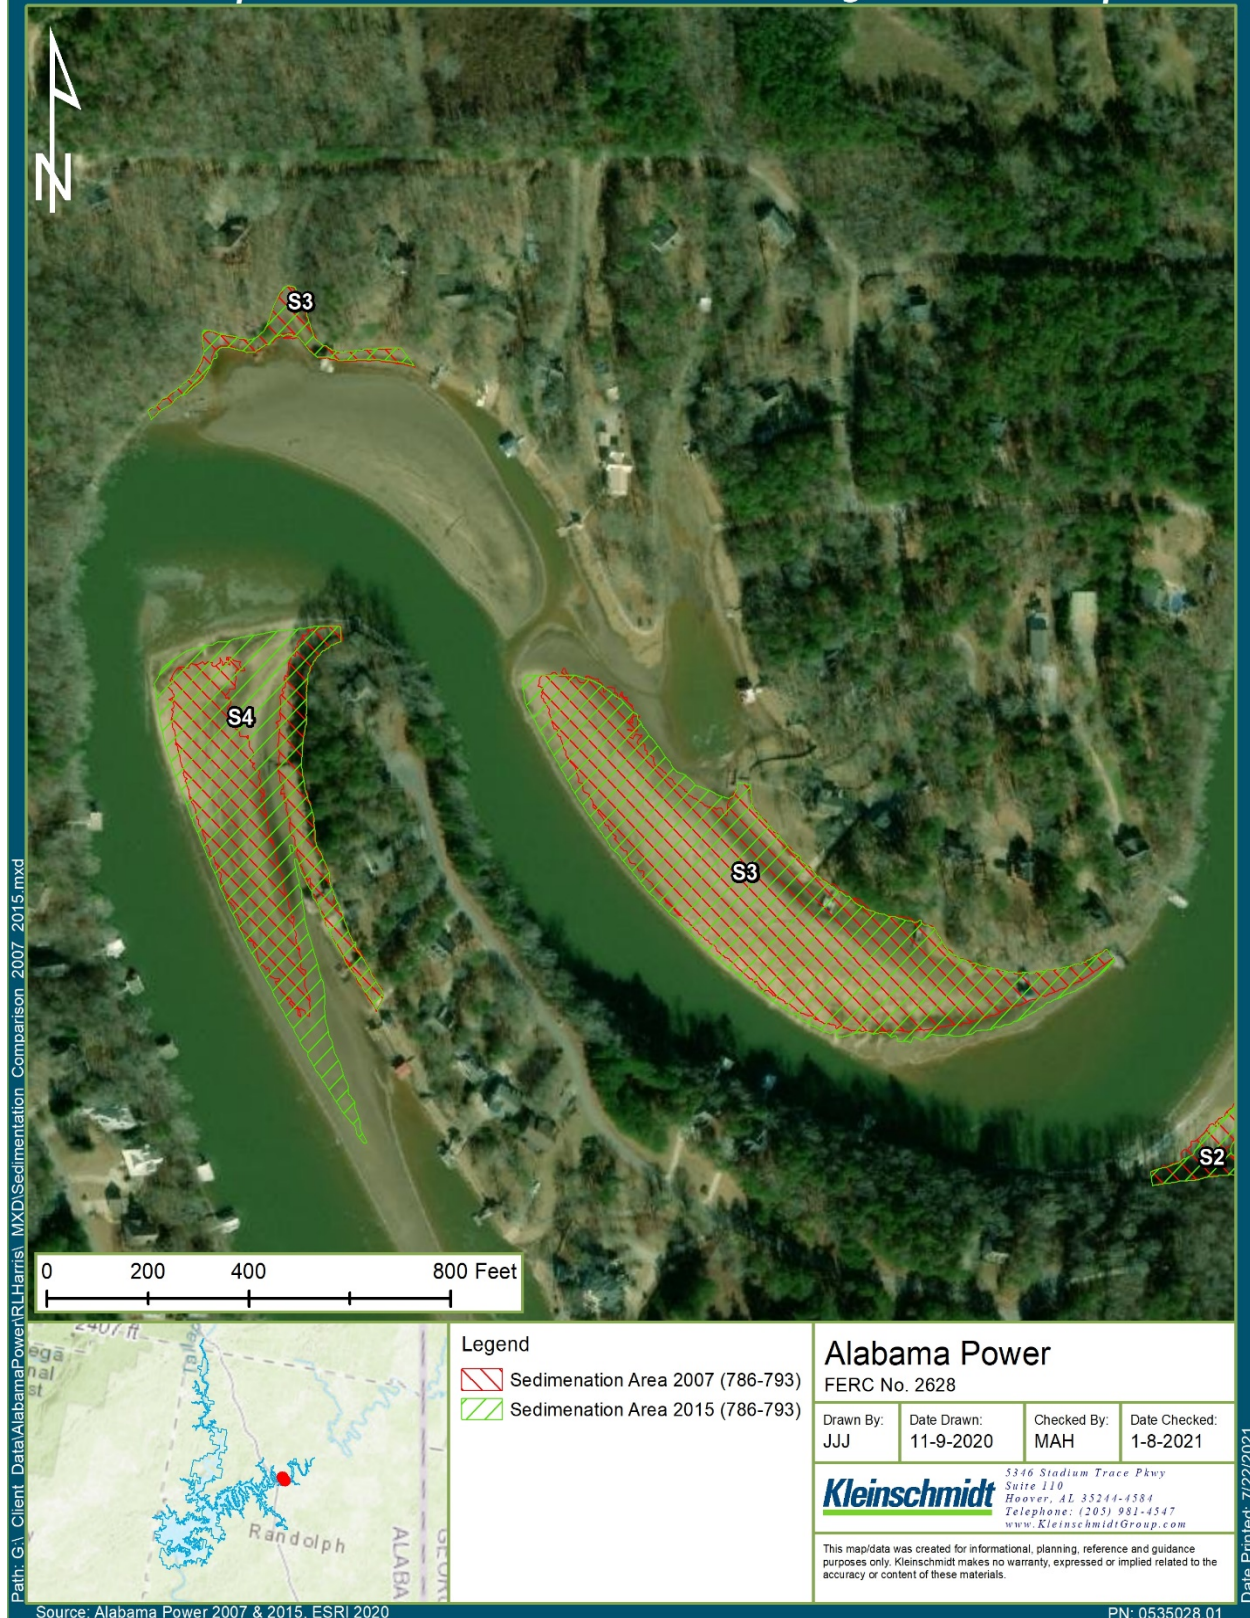
Little Tallapoosa River Sedimentation Area S3 Contour Comparison

FIGURE 2-12 SEDIMENTATION AREA S3

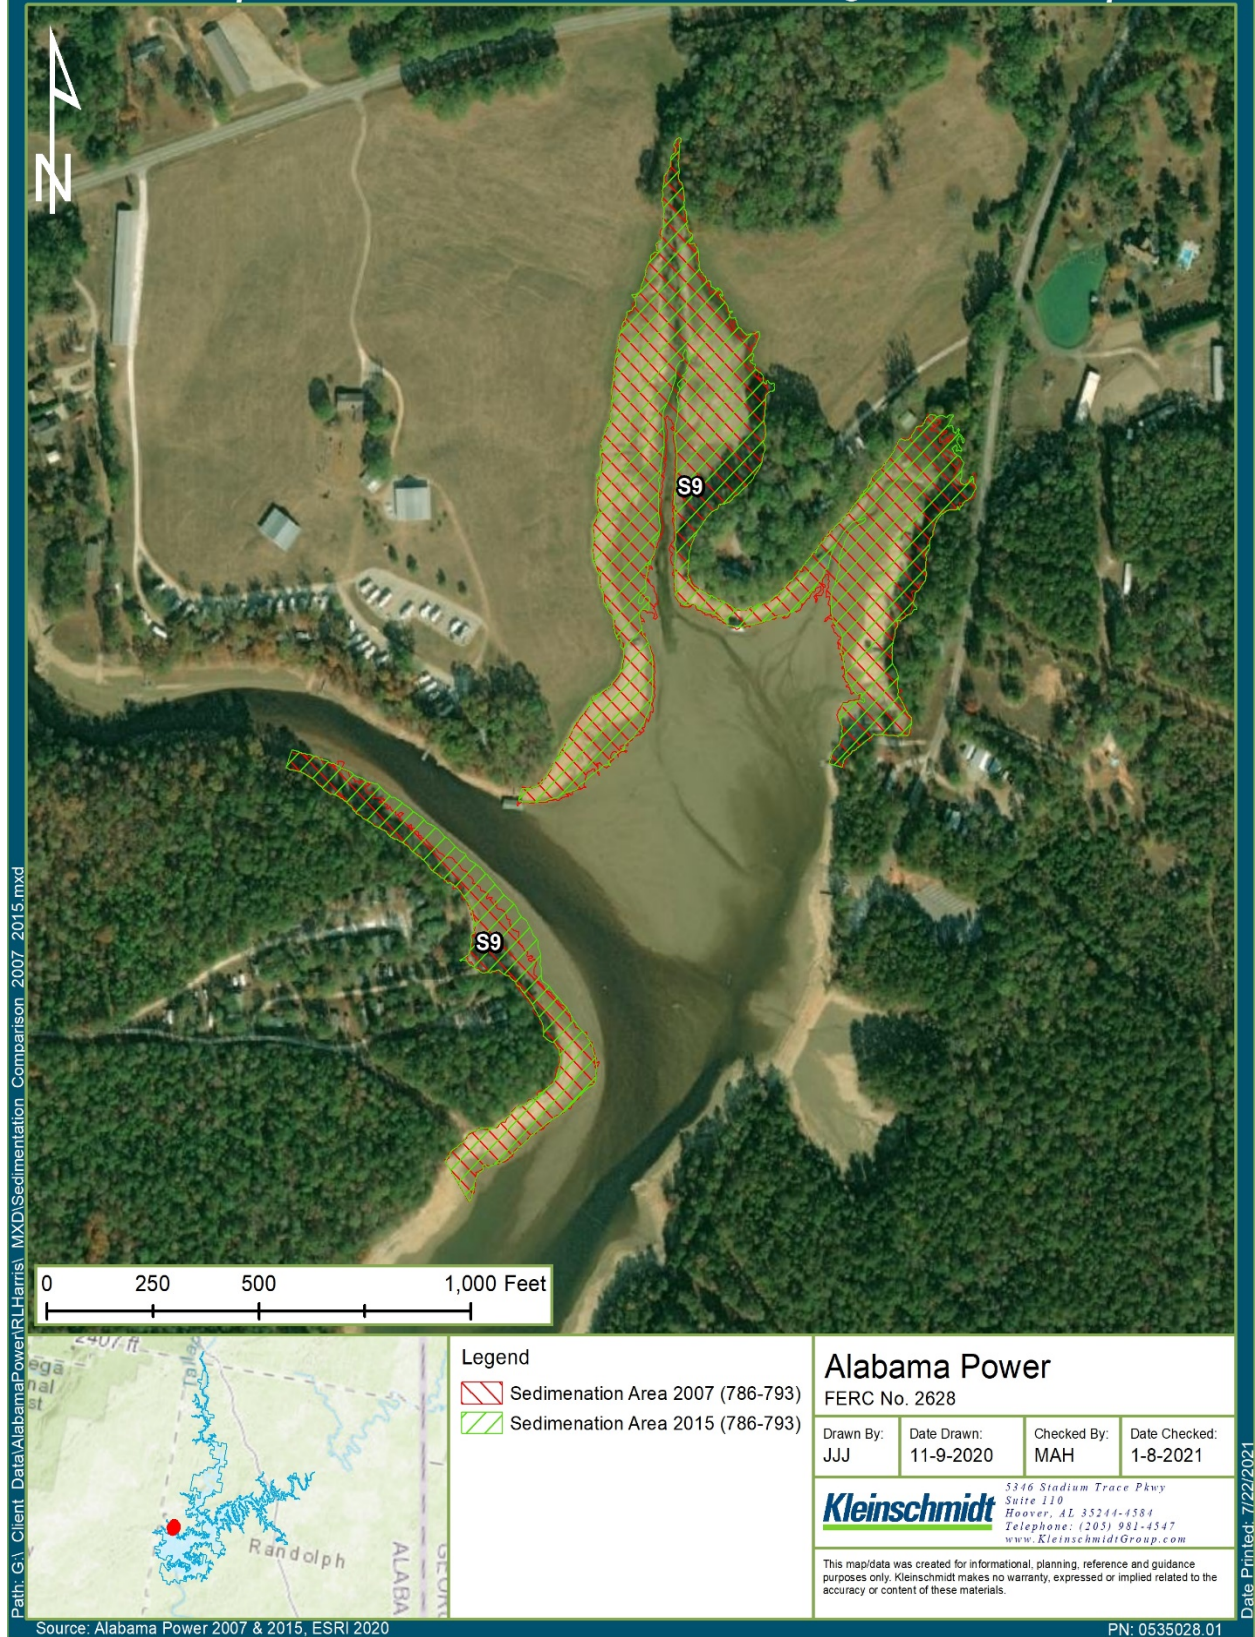
Little Tallapoosa River Sedimentation Area S9 Contour Comparison

FIGURE 2-18 SEDIMENTATION AREA S9

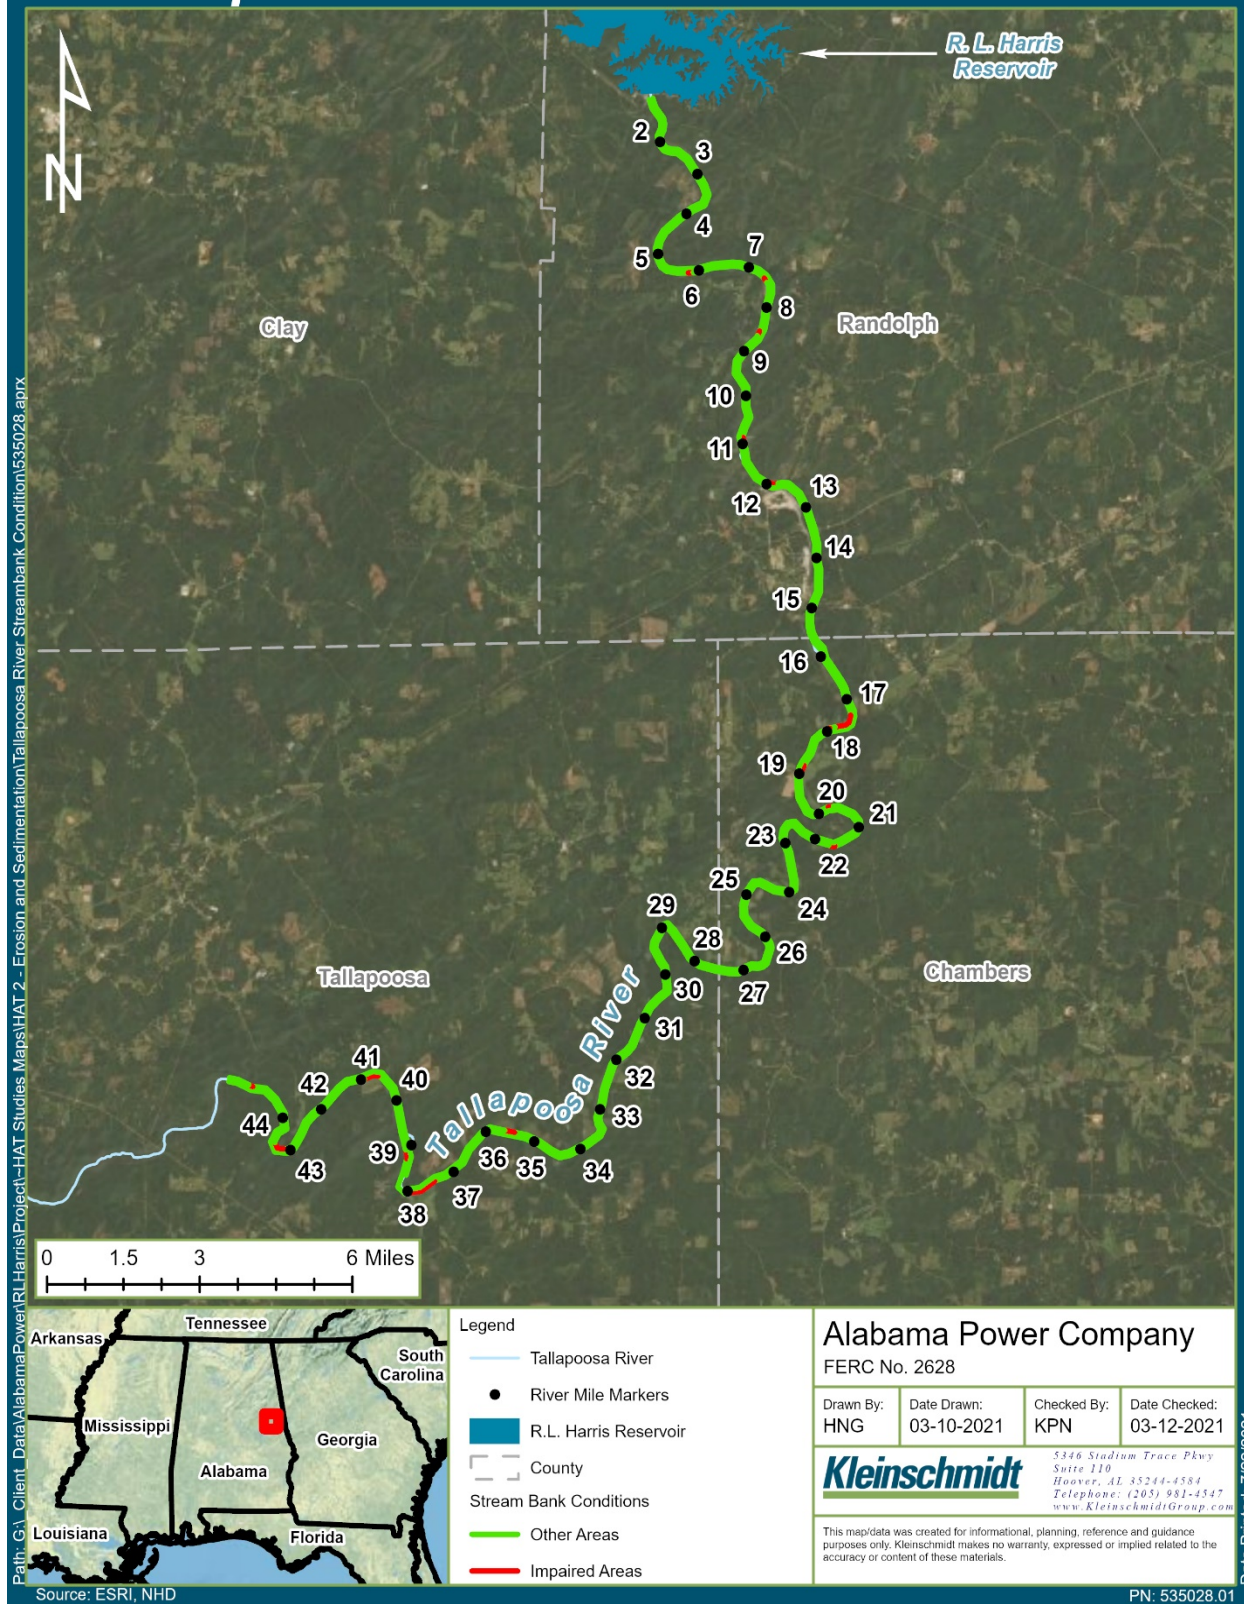
Tallapoosa River Streambank Condition

FIGURE 3-1 TALLAPOOSA IMPAIRED STREAMBANK CONDITION AREAS

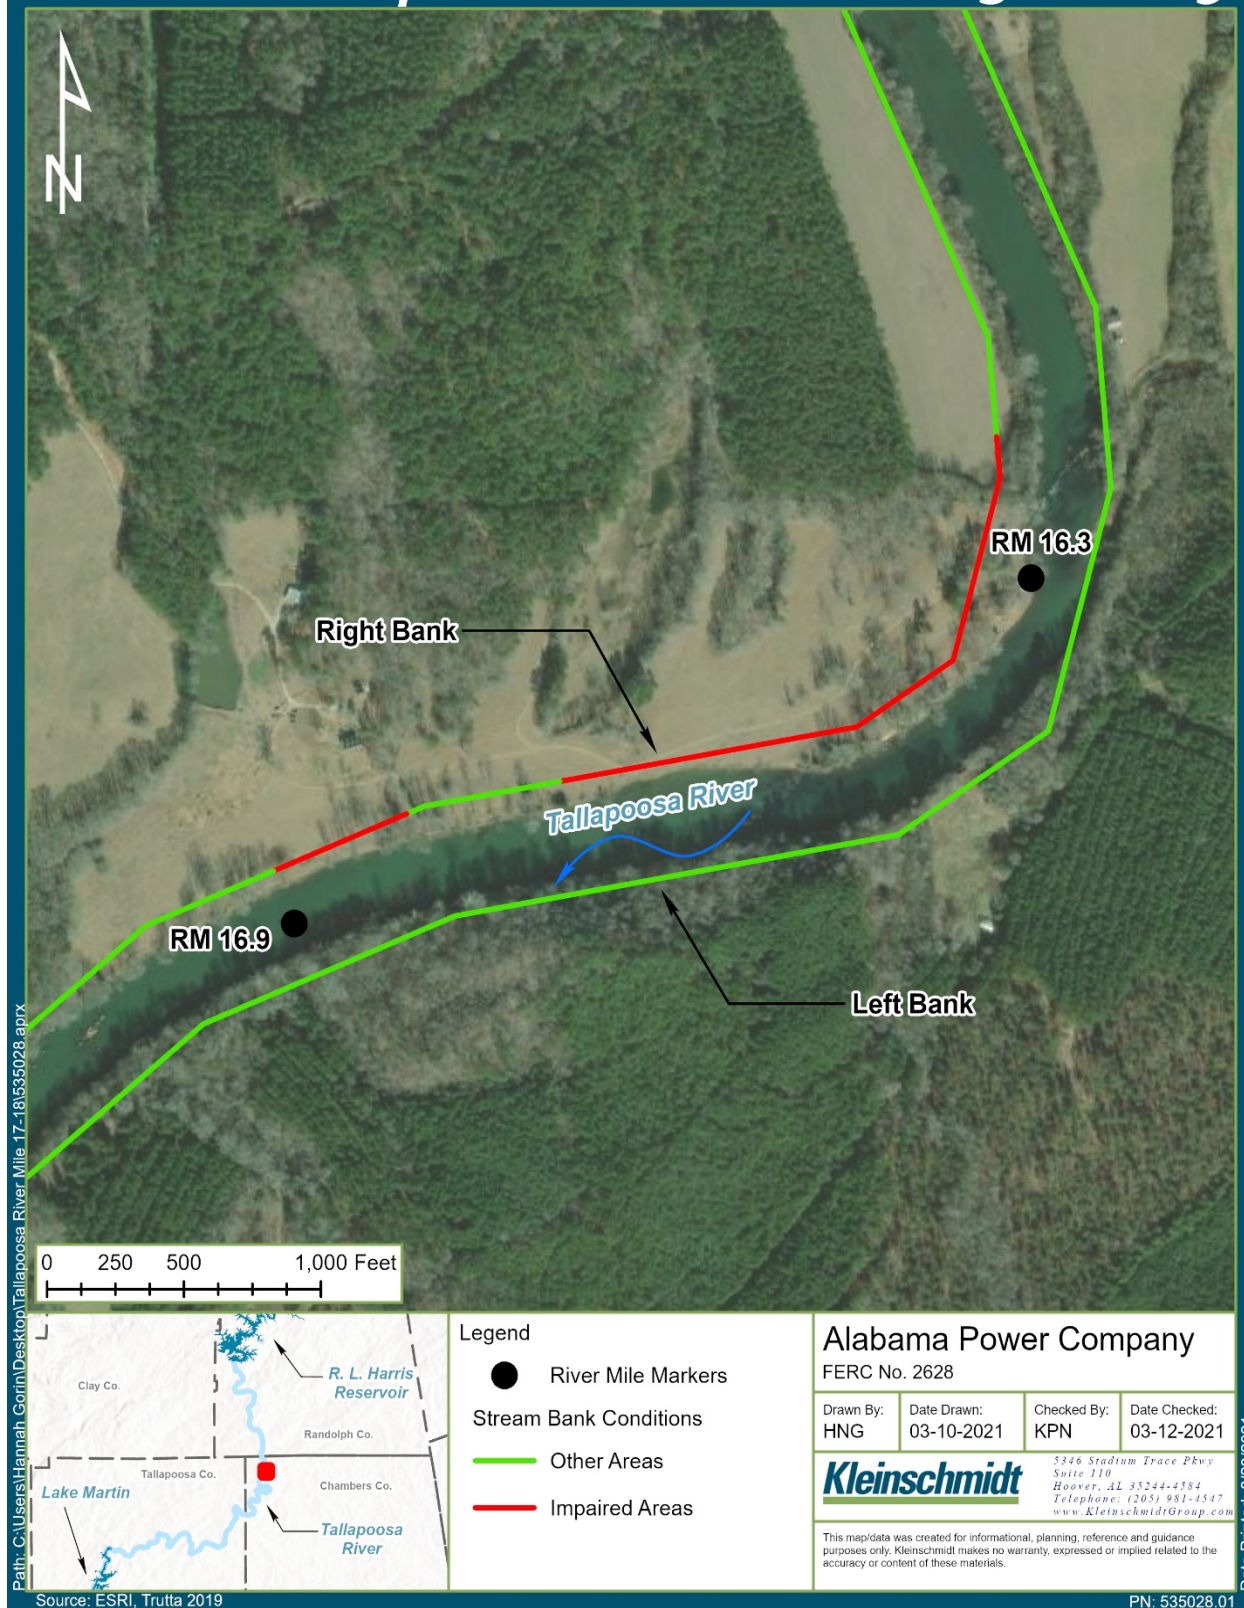
Tallapoosa River Mile 16.3 to 16.9

Streambank condition point data collected during the Trutta survey was averaged into 0.1-mile (161 m) segments to help facilitate the assessment of bank stability and erosion susceptibility. Using this data, Trutta developed a ranking system to understand specific areas of failing streambanks on the Tallapoosa River (Table 3-2 and Figure 3-1). Of the 875 0.1-mile segments downstream of Harris Dam, only fifteen sites (1.7 percent) had bank condition scores greater than three, i.e., slightly impaired or worse. Notably, only one area scored as impaired to non-functional. This area was located on the right bank at

FIGURE 3-2 TALLAPOOSA WORST STREAMBANK CONDITION AREA

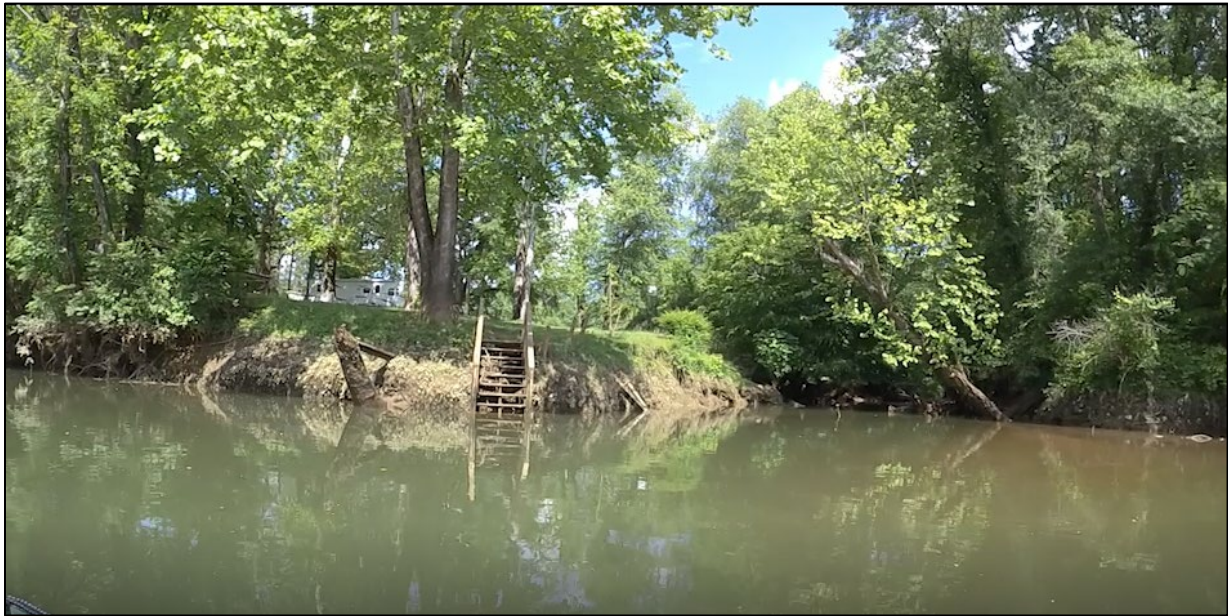
The downstream survey results included conditions for erosion sites 22 and 23 shown in Figure 2-5. These sites were also assessed using the same criteria as the erosion sites located within Lake Harris (Appendix C). Both sites were confirmed to have areas of erosion potentially caused by adjacent land use/clearing and riverine processes (Figure 3-3 and Figure 3-4). The streambank condition class for both areas was "slightly impaired," and confidence (i.e., clarity of the areas in the HDSS video used to assess streambank condition) was classified as "Good Visibility."

FIGURE 3-3 EROSION SITE 22 – IMAGE CAPTURE FROM HDSS SURVEY VIDEO

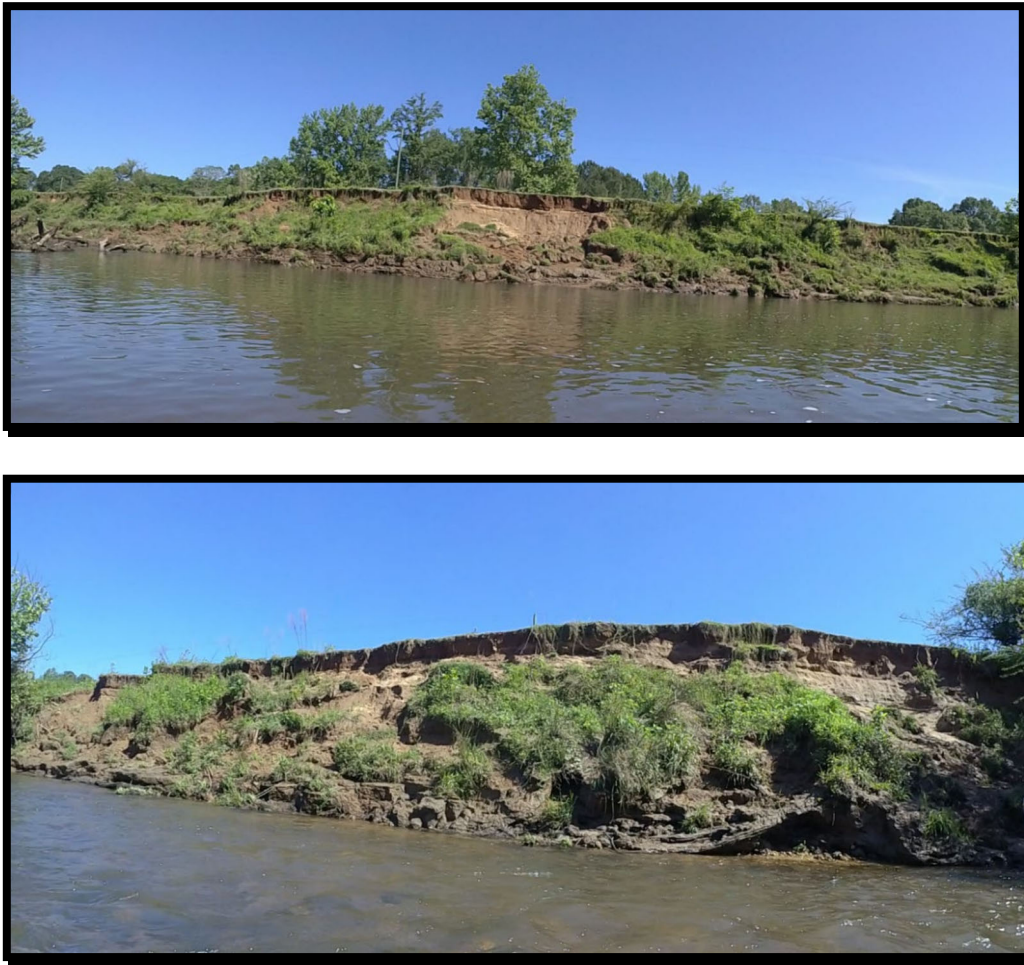
Interestingly, only one area scored as impaired to non-functional. This area was located on the right bank between river mile 16.3 to 16.9 (Figure 30). This is a very positive finding as many rivers we have surveyed in the Southeastern US have much more extensive bank erosion issues.

Figure 30: Example images of worst area on right bank of the Tallapoosa River between river mile 16.3 and 16.9.
