EROSION AND SEDIMENTATION STUDY REPORT

R.L. HARRIS HYDROELECTRIC PROJECT

FERC No. 2628

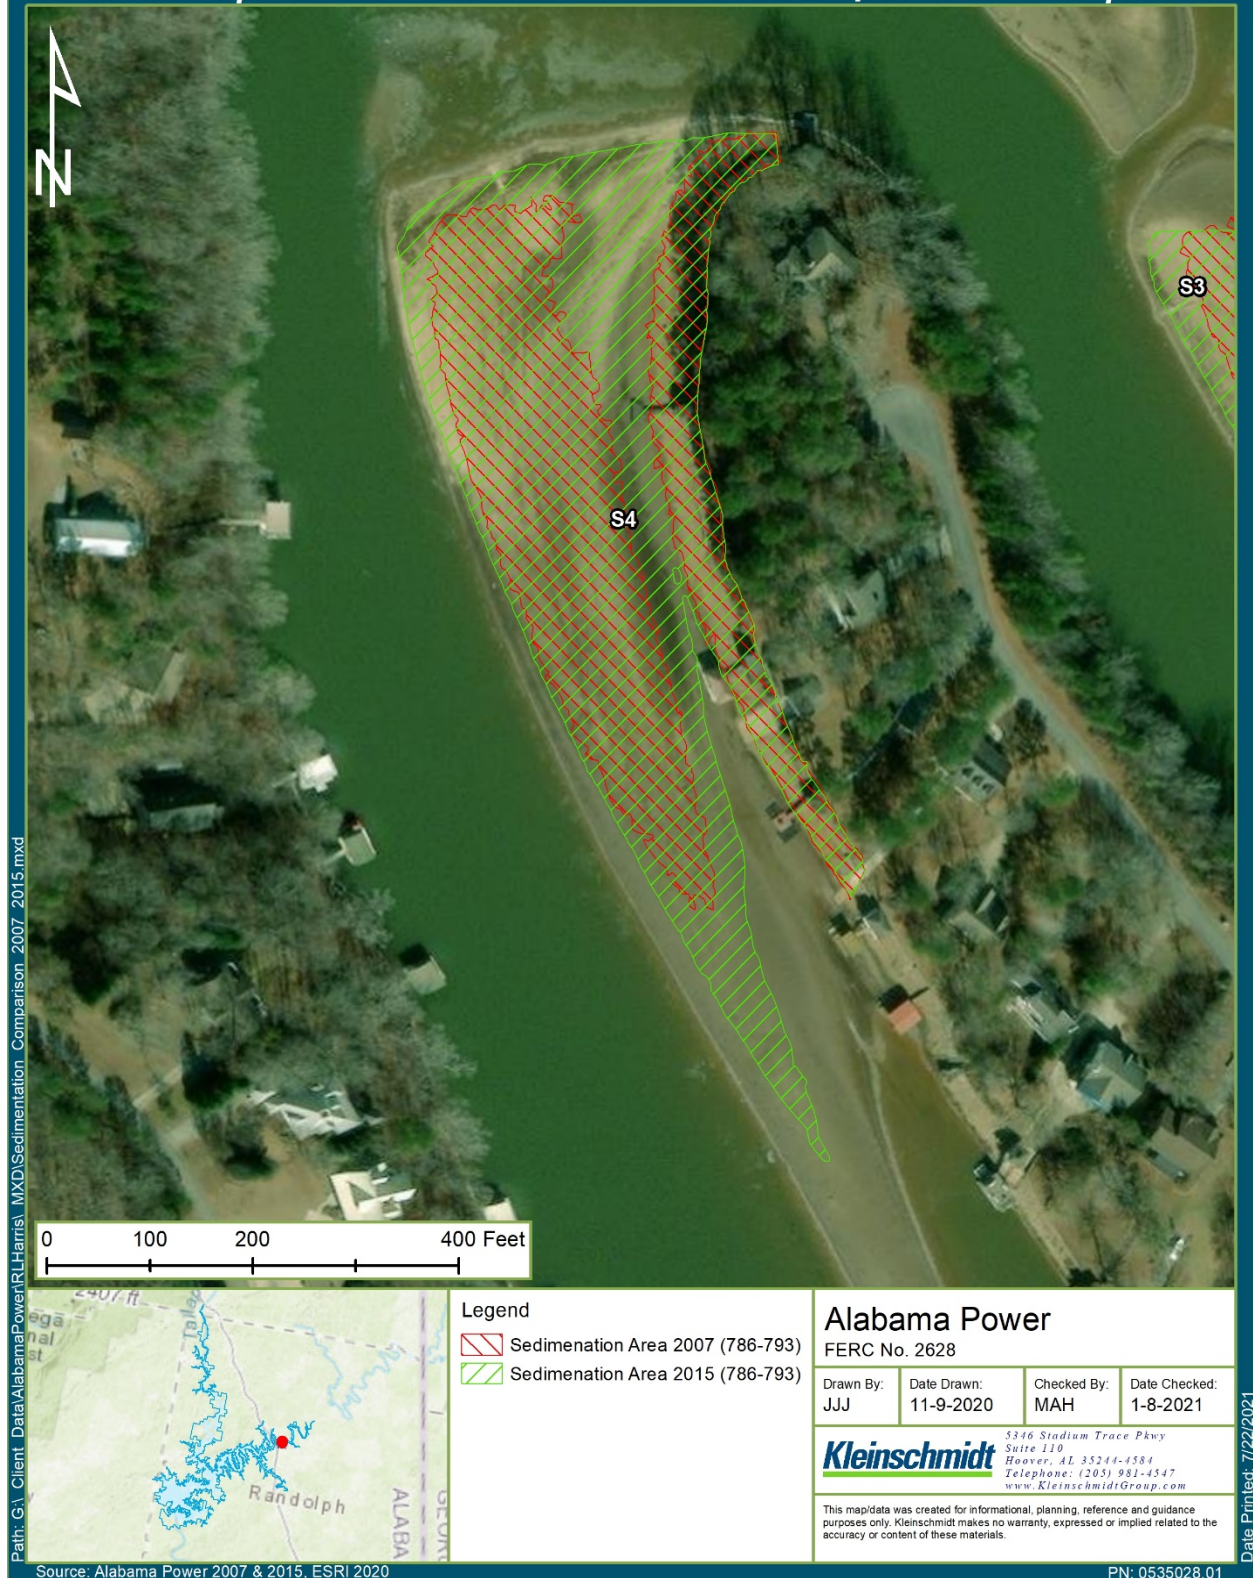
FIGURE 2-13 SEDIMENTATION AREA S4

Name	2007 Acreage	2015 Acreage	Change (acres)	Change (%)
S1	19.28	19.86	0.58	3
S2	1.29	1.65	0.36	28
S3	5.40	6.09	0.69	13
S4	2.47	3.99	1.51	61
S5	1.51	4.11	2.60	172
S6	5.55	6.12	0.57	10
S7	16.47	17.70	1.23	7
S8	10.08	9.65	-0.42	-4
S9	11.44	11.69	0.26	2

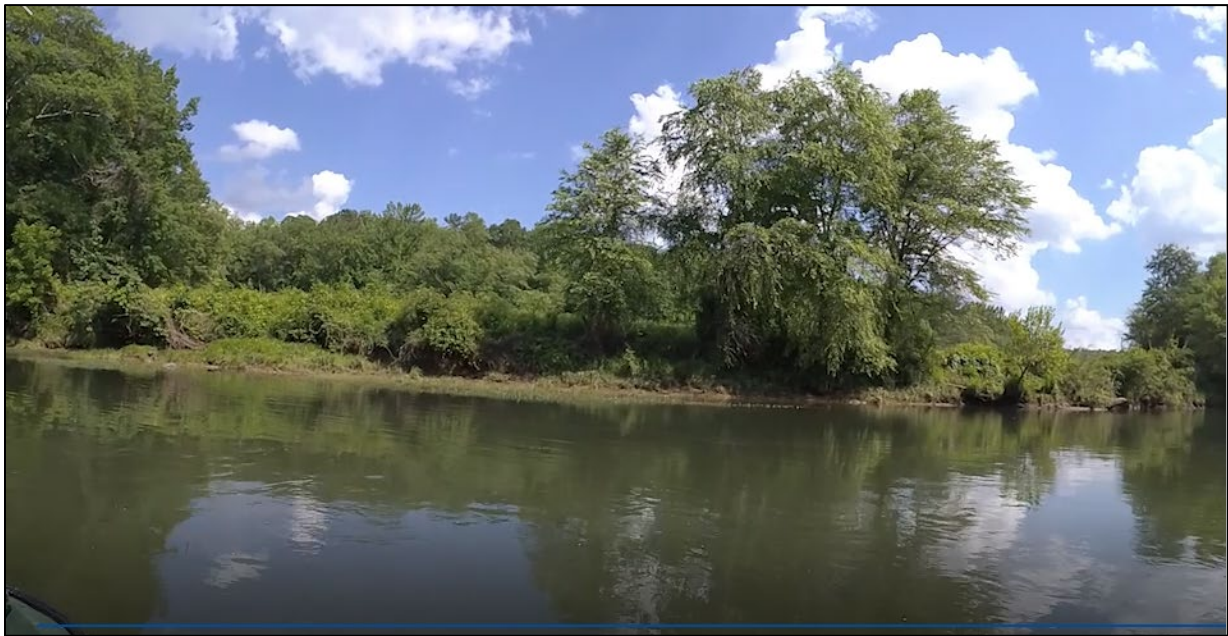
FIGURE 3-4 EROSION SITE 23 – IMAGE CAPTURE FROM HDSS SURVEY VIDEO

The downstream survey results included conditions for erosion sites 22 and 23 shown in Figure 2-5. These sites were also assessed using the same criteria as the erosion sites located within Lake Harris (Appendix C). Both sites were confirmed to have areas of erosion potentially caused by adjacent land use/clearing and riverine processes (Figure 3-3 and Figure 3-4). The streambank condition class for both areas was "slightly impaired," and confidence (i.e., clarity of the areas in the HDSS video used to assess streambank condition) was classified as "Good Visibility."

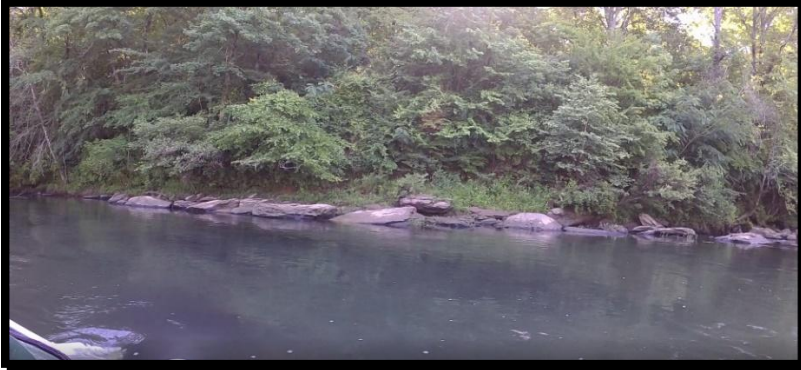
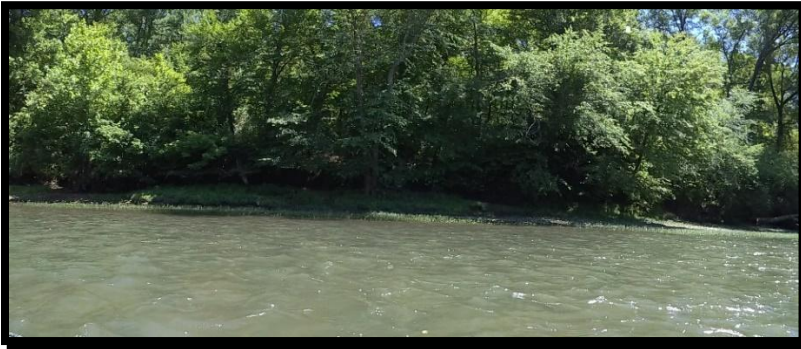
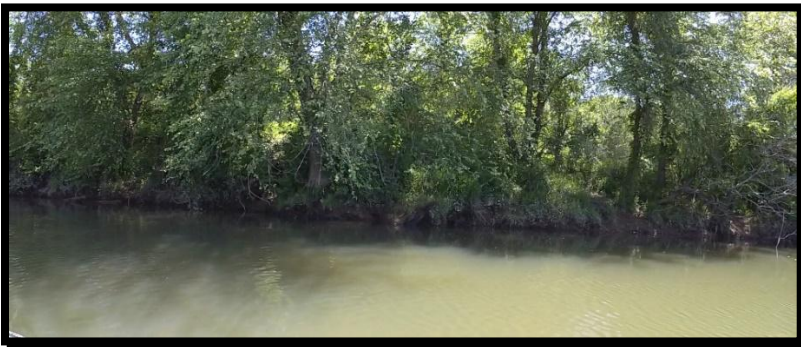
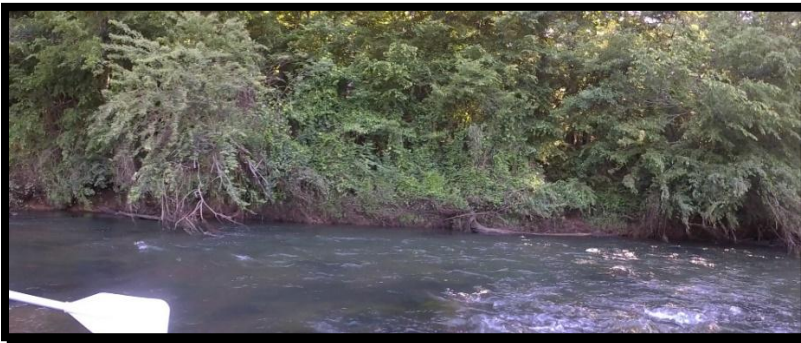
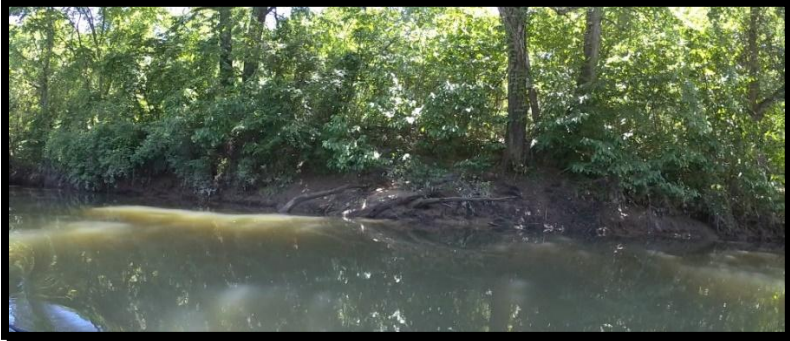
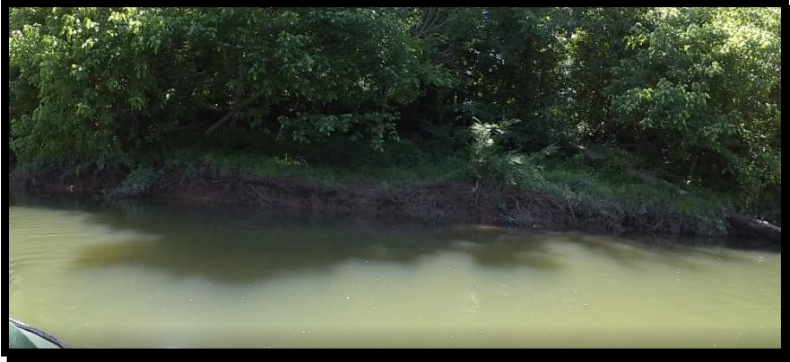
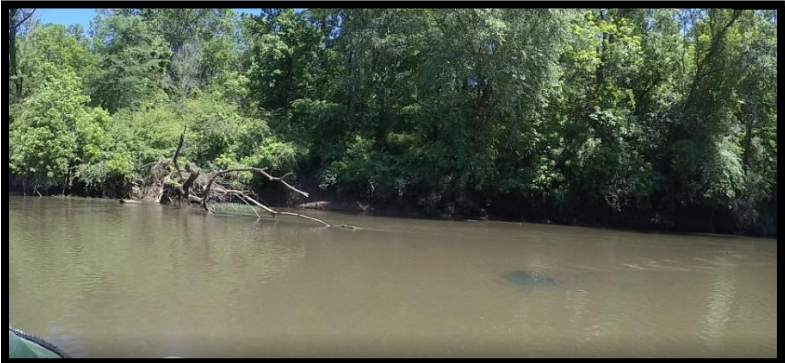
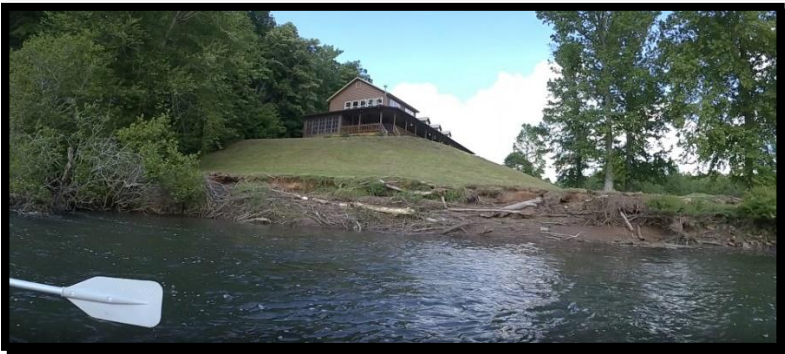
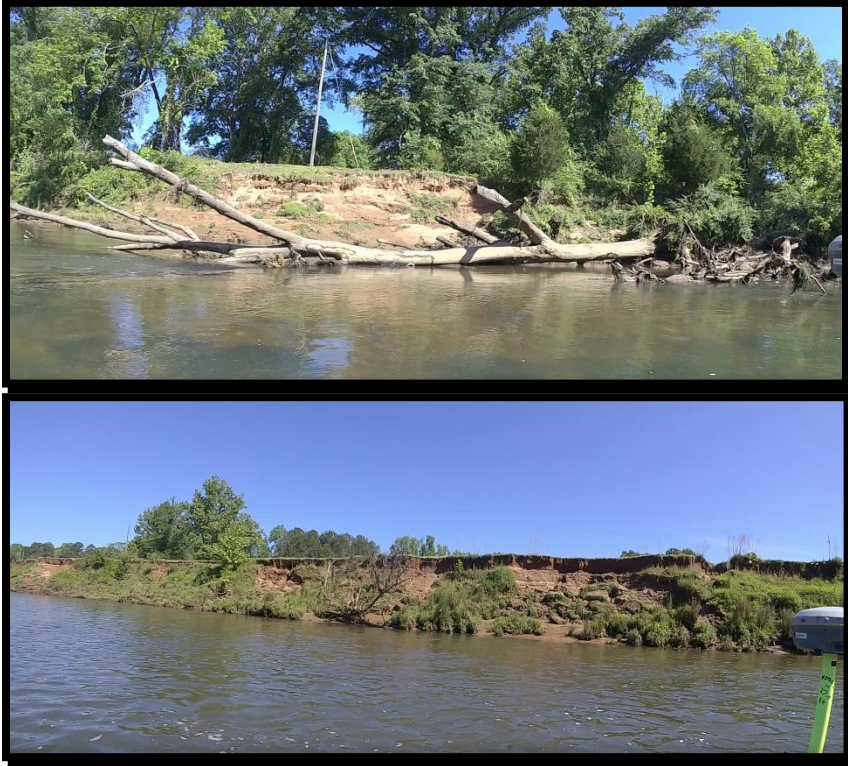
Figure 11: Examples from the Tallapoosa River survey of the five streambank impairment classification levels.

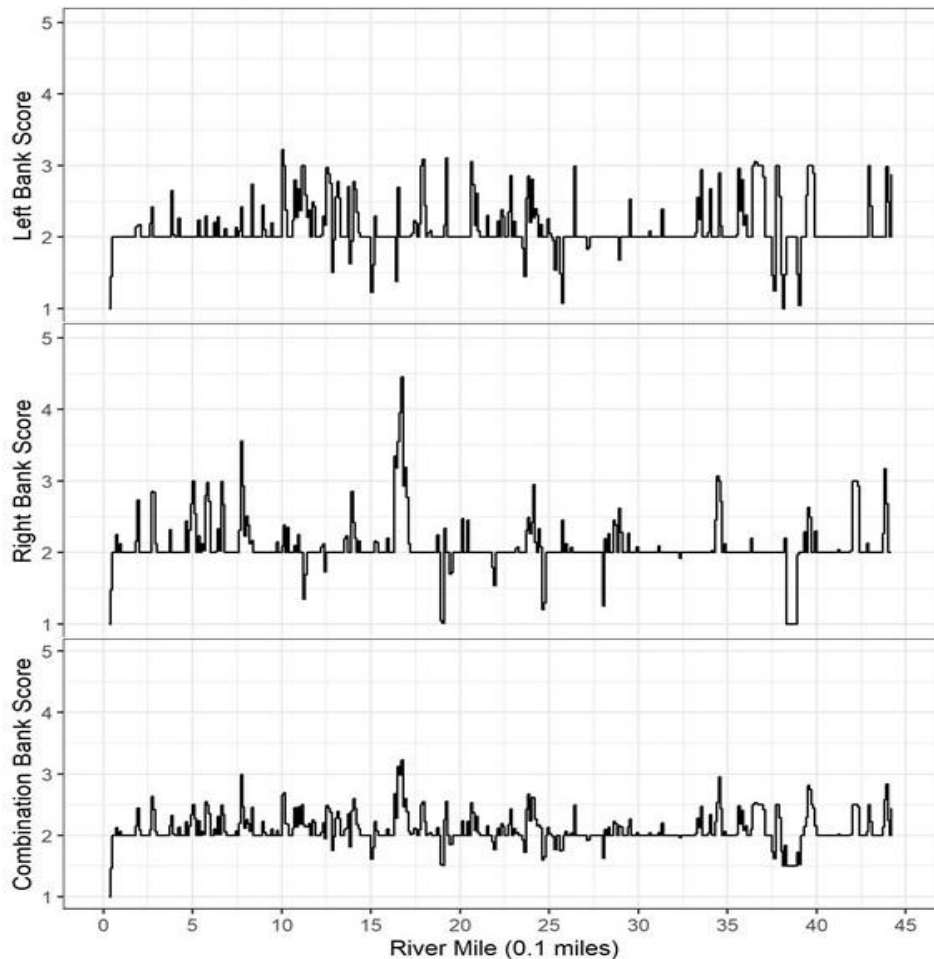
Figure 24: Average bank condition score by river mile (0.1 mile)

The data for both tracklogs were integrated onto a centerline track of the Tallapoosa River to facilitate comparisons. There was little trend, either increasing or decreasing in a downstream direction for the occurrence of bank condition scores (Figure 24). The average water depth deepened in a downstream direction, but shallow shoals were still present throughout the survey segment (Figure 25). As with the point data for water depth, the discharge fluctuations associated with power generation influence both between-day and during-day water depths and should be used with caution. Integrated maps of left and right track water depth and left and right streambank condition are shown in figures:

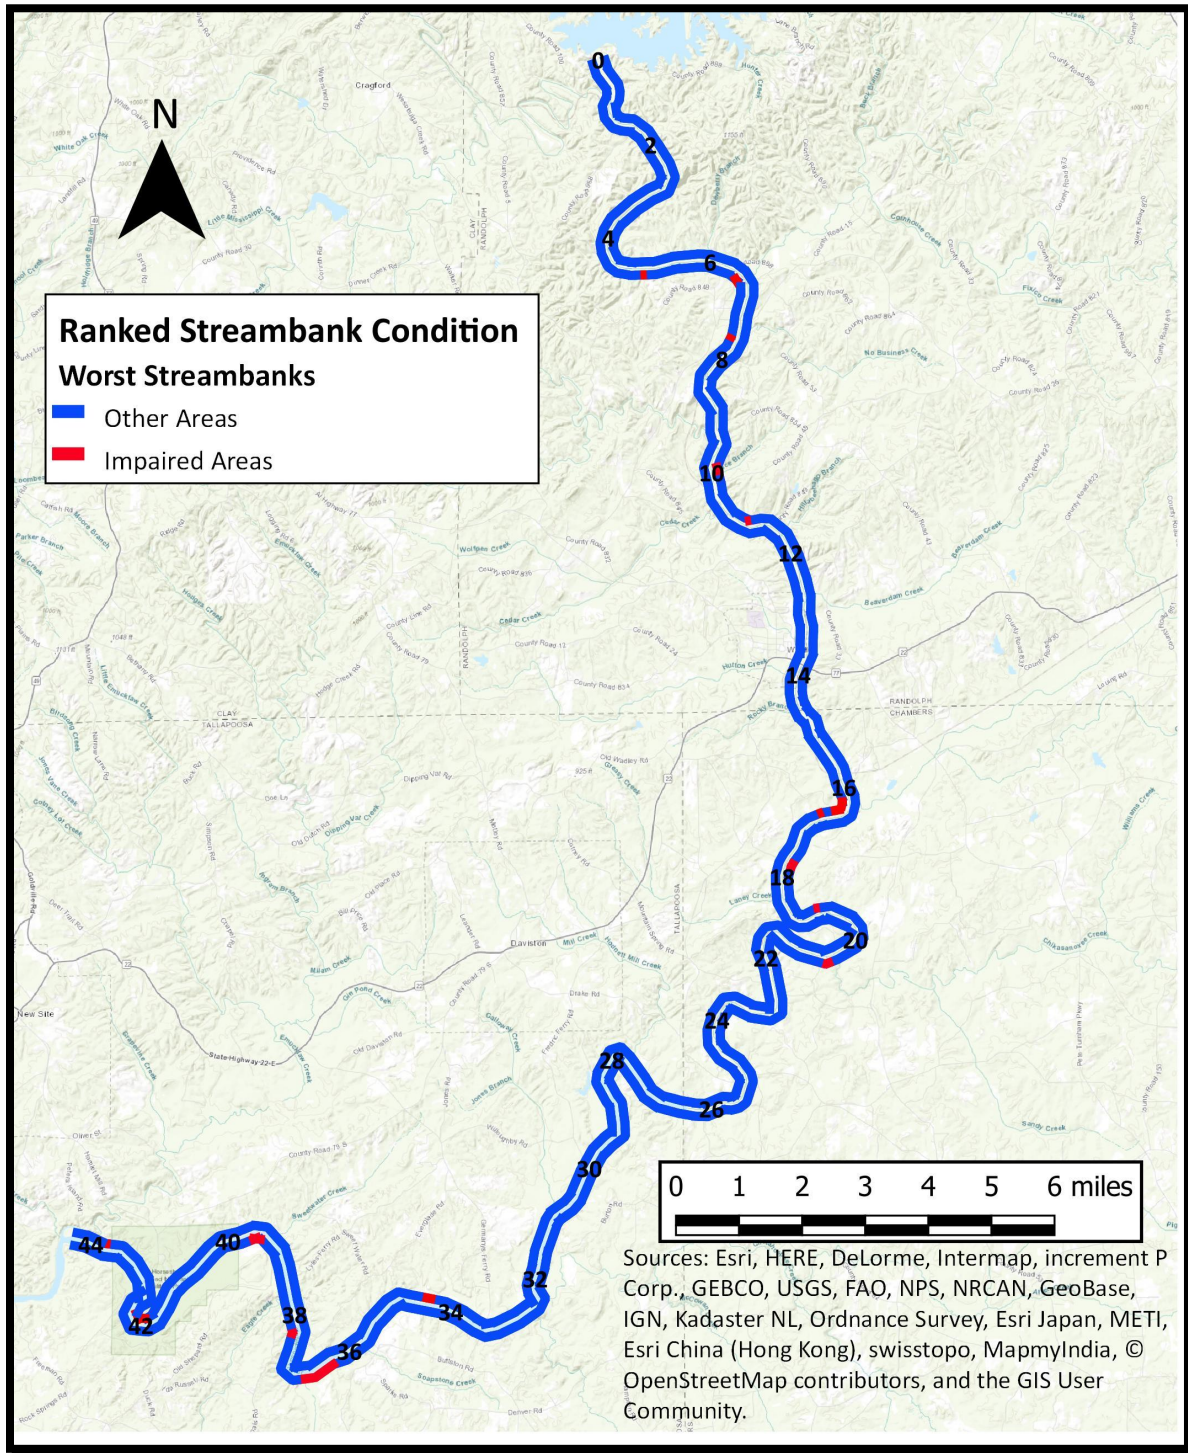
Figure 31: Worst Bank Condition Areas from the HDSS results for the Tallapoosa River.

Another goal of the project was to rank the Top 15 worst streambank areas to allow managers to better understand specific areas of failing streambank on the Tallapoosa River. We averaged the point information into 0.1-mile (161m) segments to help facilitate finding the problem areas. Table 3 and Figure 31 to Figure 34 show the results of this ranking. A total of 20 sites were provided for the left bank segments as many segments were tied with a score of 3 (slightly impaired).

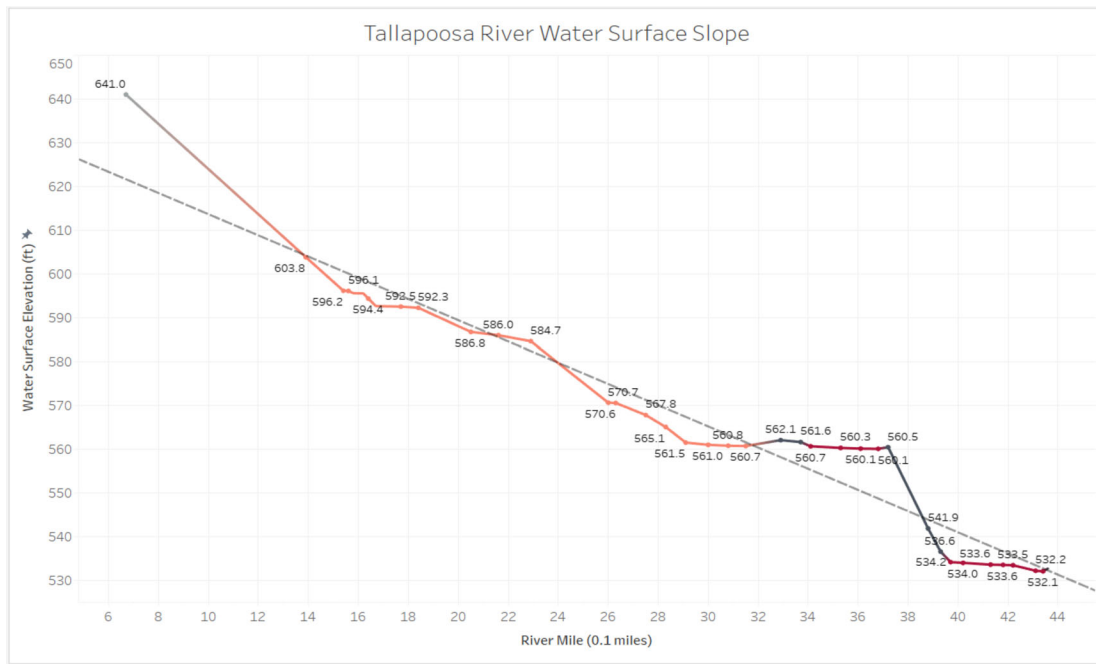
Figure 36: Water Surface Elevation to River Mile for the Tallapoosa survey. Colors reflect different days of the survey. The dotted line is the linear trend line.

A plot of water surface elevation as compared to River Mile showed that the river was generally falling at a consistent rate except for a large elevation drop between miles 37.2 and 38.8 (Figure 36). A linear trend model was computed for Surface Water Elevation given River Mile (Table 5). The model was significant at $p \leq 0.001$. The generalized slope model predicts that the Tallapoosa River drops 2.4 ft per mile.
