Project No. 2628-065
R.L. Harris Hydroelectric Project
Transmittal of the Draft Erosion and Sedimentation Study Report

DRAFT
EROSION AND SEDIMENTATION
STUDY REPORT

R. L. HARRIS PROJECT
FERC NO. 2628

APRIL 2020

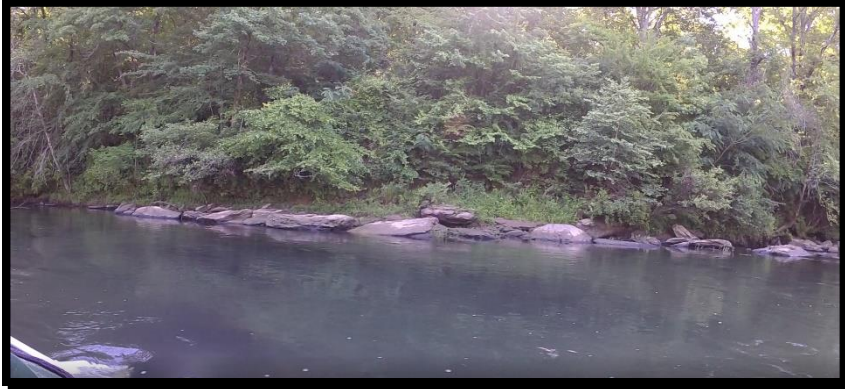
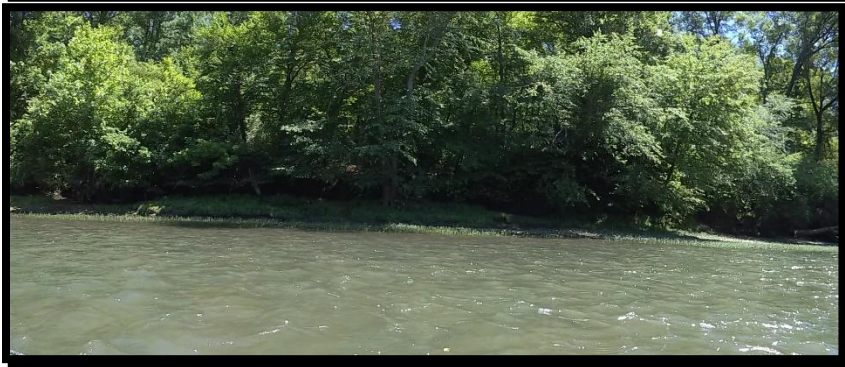
1: Fully Functional

Figure 11: Examples from the Tallapoosa River survey of the five streambank impairment classification levels.
